Report No.: HC20112/2013

Product Description: Network Camera

Style/ Item No.: FD8151V/No.1

## 1. Impact Test:

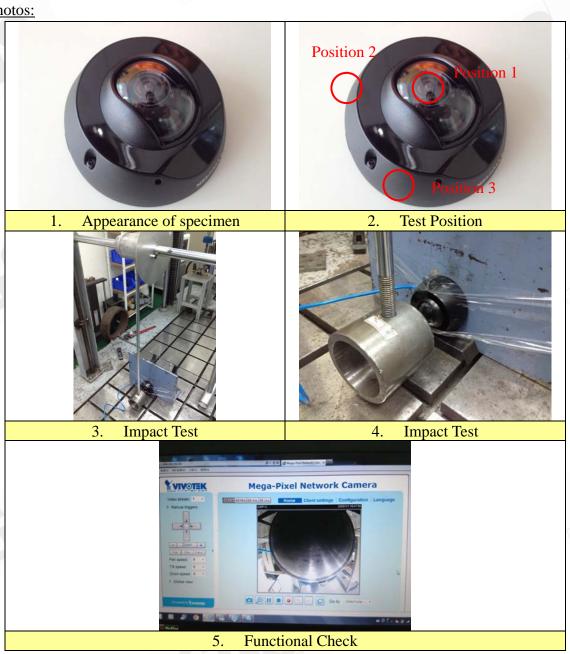
**Test Photos:**

Position 1~ Position 3(see photo 2) **Test Position:**

Testing device: As shown in photo 3, 4
