Report No.: HCN0178A/2012

Product Description: NETWORK DYNAHAWK W2 SERIES

1. Impact Test

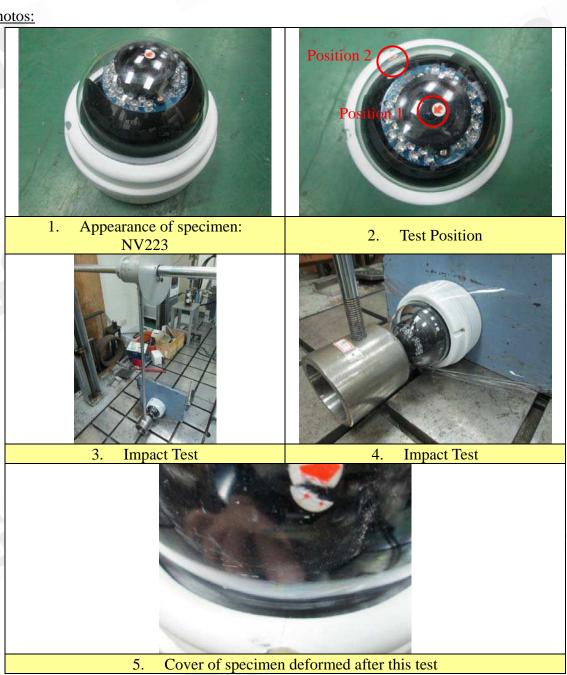
Test Photos:

Position 1, Position 2 (see photo 2) **Test Position:**

Testing device: As shown in photo 3, 4

Style/ Item No.	Check Item	Appearance check (visual check)
NV223/ No.1	Position 1	No visible damage
	Position 2	Cover of specimen deformed after this test (see photo 5)
